Silicone Roof Holds Up in Tropical Climate ROOFING PROJECT PROFILE

Multi-family High Rise
2033 Nuuanu Street
Honolulu, Hawaii

Concrete deck
SBS Cap Sheet
Estimated at 10+ years old

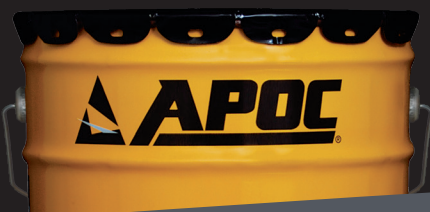
With signs of moisture issues common to insulation over an aged cap sheet roof, the 25 story multi-family high rise at 2033 Nuuanu Street in Honolulu, Hawaii required immediate attention. As a certified thermographer, APOC representative Jim Eurton completed an infrared thermography inspection revealing moisture around

parapet walls, walk pads, exhaust vents and pipe vents, as well as near a stairwell and under mechanical equipment. “It is important to remove and eradicate moisture, especially wet insulation as it has nowhere to go besides down through the deck. The result is a serious mold risk,” said Jim Eurton.

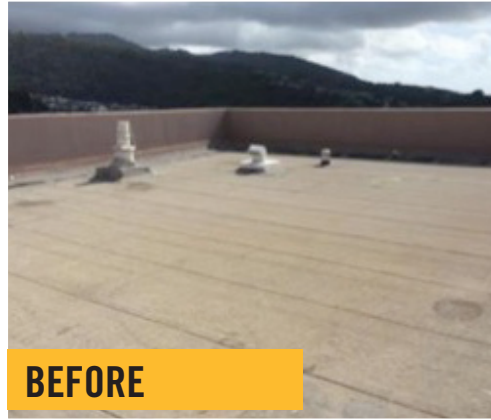
BEFORE

The infrared readings detected moisture from the wall at the stairwell building proving this area appeared to have ponding water issues.

Wet insulation and decking were removed and new materials were installed, allowing for the contractor to complete the roof restoration. Materials included in the APOC System included:

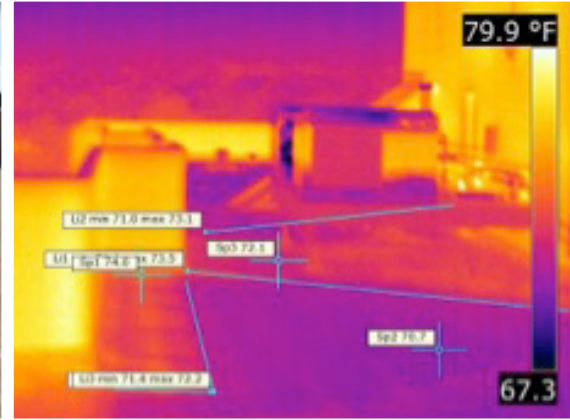
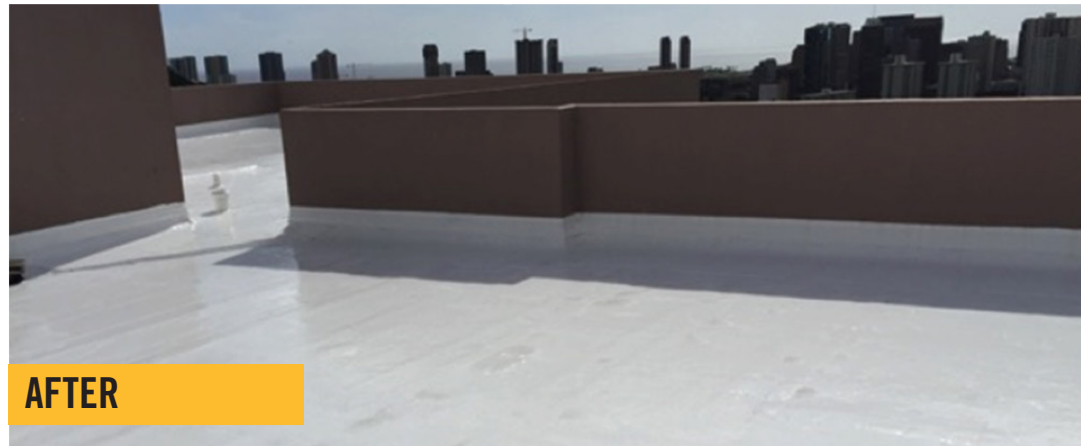
AFTER

The APOC System selected for this restoration, APOC Guide Specification AM-BU-585, delivered a durable waterproof membrane over the existing roof surface which had retained structural integrity but had become weathered and deteriorated.

- **APOC #483 Polyester for flashing reinforcement**
- **APOC #515 Liquid Flash for flashing and details**
- **APOC INCREDIBLE FleeceTop Tape for flashing and details**
- **APOC #585 ArmorFlex White Silicone Roof Coating**
